LIME MORTARS: TWO RECENT CASE STUDIES*

Joshua Freedland¹ and Edward A. Gerns²

1.1 Case study 1

1.2 Case study 2

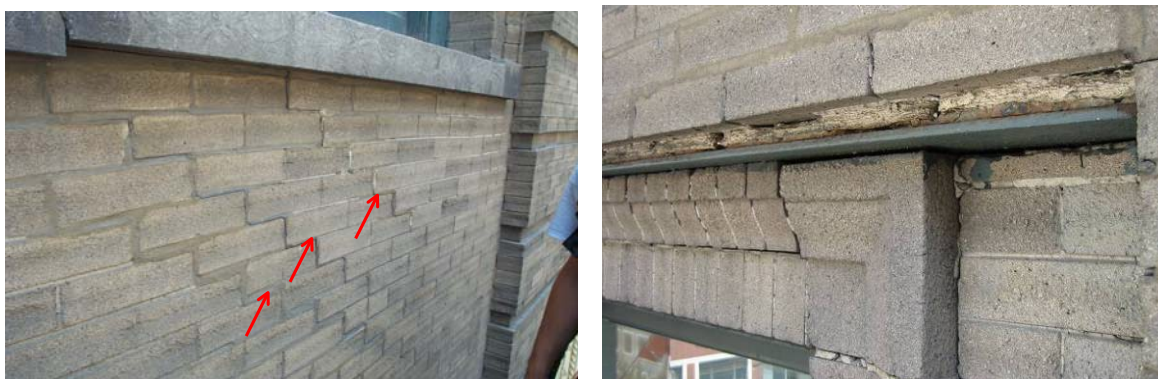
The current phase of work resulted from a routine inspection of the building facade, when isolated masonry repairs were deemed necessary based on external observations and a limited number of inspection openings. In general, conditions observed during the evaluation indicated distress consistent with restraint of structural and thermal movements. Offset cracking within sill areas, missing mortar, and step cracking primarily through mortar joints were identified in the corner bays.

Figures 2 and 3 Representative examples of cracked brickwork at corner (right) and joint conditions (left)

Deterioration of the brick and damage resulting from previous cleaning had significantly compromised the fired skin of the brick, leaving them more susceptible to future damage. Further, crack patterns in the end bays strongly suggested that thermal movements and differential structural movements were the cause of mortar joint cracking within the spandrel sections of the wall. Given the size, scale, architectural details, and context of the building, introduction of expansion joints within the wall system

The first phase of the repair project included repointing of the brick masonry and other limited masonry repairs at the end bays of the building. Lime-sand mortar was selected to repoint the brickwork on the masonry facade for a variety of reasons. While chemical testing was beyond the scope of the project, the existing setting mortar installed throughout the facade appeared to be portland cement-lime-sand mortar, as would have been typical of the 1920s facade recladding project [Kidder-Parker, 241–246]. The composition of the backup mortar was not determined and, as mentioned previously, may date from the original 1870s construction. Lime-sand mortar is consistent with Chicago building practices in the 1870s and was likely used at that time [Speweik, 1995].

would have been visually intrusive. Yet, a means of addressing movements was desired to improve the serviceability of the facade. Lime-sand mortar was, therefore, selected to minimize potential future cracking of the masonry wall. If movement continued, the use of a lime-sand mortar would result in the preferential cracking of the mortar joints (sacrificial) rather than the fragile historic brick. The autogenous healing properties of lime-sand mortar was also desirable for this application since cracking of the mortar joints was likely to continue as a result of continued thermal and structural stresses. Despite limited cracking within the lime-sand mortar joints, the brick masonry would continue to function monolithically.
