A CASE STUDY IN INTERVENTION ON ORIGINAL SURFACES*

Maria Margalha¹

This paper discusses some methodologies used to assess the condition of original surfaces and the structural repairs carried out at a church in a small village in southern Portugal. The church dates back to the beginning of the 16th century, but it underwent significant alterations in the 17th, 18th and 19th centuries.

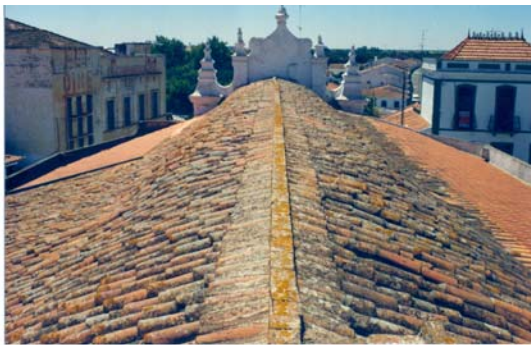
The main causes of degradation were damaged rain-water drainage systems, broken tiles and proliferation of biological growth on the roofs (Figure 4). These problems resulted in serious water infiltration problems in the vaults, walls, plasters and decorative finishes (Figure 5).

Figure 4- Old roof building. The new tiles seen in this picture belongs to private building adjoining the church.

The ceramic tiles were completely removed from the roof. The extrados of the large vault and small vault were cleaned of loose materials and dust. In order to fill in the cracks and avoid development of new deficiencies similar to the ones already mentioned in the main barrel vault, an expanded steel mesh (20x25 mm) was applied. That mesh was overlaid at the junctions by a 50 mm layer of micro-concrete made from 1 part cement : 1 part sand : 2 parts gravel. After application of a synthetic roof-tile underlay to stop water infiltration, the roofing was reapplied, using similar ceramic tiles laid with lime-cement mortar. The original shape of the roof, with one accentuated inclination, was maintained (Figures 8 and 9).

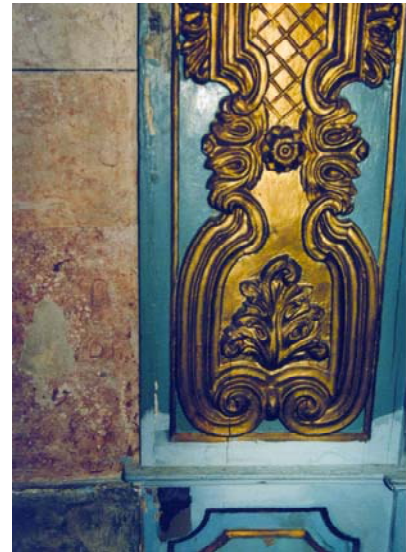
The great tradition of stone use in Portuguese monuments led to the use of polychrome decorations to imitate stone. In this church, the imitation was probably due to economic reasons. Wall plaster that tries to imitate marble is shown in Figure 2.

In the wooden altars, painted now in blue and gold, there is a hidden painting of stone and gilt-work (Figure 2).

Figure 2- Detail of the plaster walls and the wooden altars in the central aisle

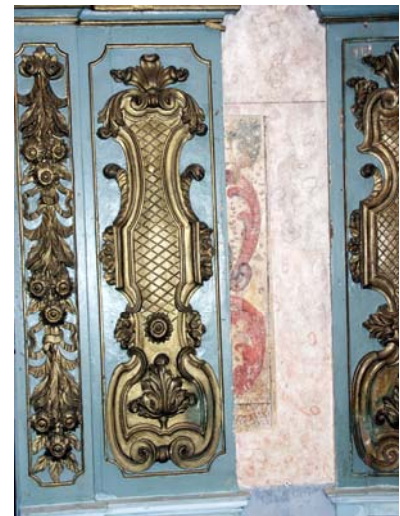
The stratigraphy of the interior coatings showed that the whole church must have originally been decorated with frescoes that can be found on the walls and the vaults (Figure 3). These frescoes are still hidden under the multiple layers of later finishes. They were visibly damaged by a general peeling that became the basis for the present plaster coatings on the vaults and on secco paintings on the walls.

Figure 3- Detail of fresco paintings discovered on the walls

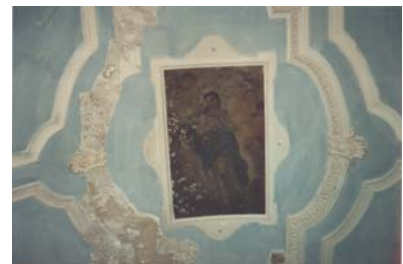
Figure 5- Detail of the lacunae of gypsum plaster at the vault of central aisle

The gypsum plaster decoration on the ceiling was deteriorated due to water infiltration over the years.

Areas with deficient adhesion were fixed using lime putty mortars, plaster and consolidating materials (one resin mixed with a small percentage of Plextol). Decorative plaster pieces that were missing from the central aisle's vault were replaced by using the existing pieces to create silicone molds. Missing pieces of gypsum plaster, namely in the flower work and in a statue of Saint John the Baptist represented by a lamb, were re-made based on the parish priest's memory and attached to the vault. All the pieces were made with lime putty and gypsum (Figure 12).

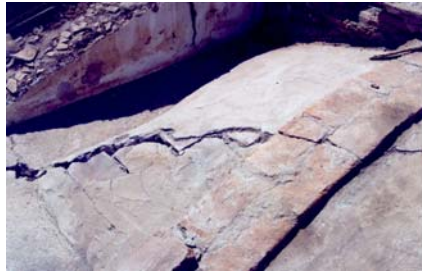
At that time, we saw slight cracks on the vaults and a slant on the sidewall of the vestry. These were caused by foundation problems, which led to serious damage in the small vault (Figures 6 and 7).

Figure 6- Structural damage on the exterior of the vestry vault

The obvious loss of stability in the vestry's small vault required its structural reinforcement. Conservation of this kind of vault is very difficult because the necessary compression between bricks and in the small area of the tops of the bricks is lost. With the emergence of larger

cracks, structural stabilization was quite impossible. Therefore, the decision was made to restore the vault with new techniques and materials (Figure 10).

A 20x25 mm expanded steel mesh was applied on the interior and exterior faces of the vault, and fixed with clamps in a 0.40x0.40 m² pattern. The mesh was covered on the exterior by micro-concrete and on the interior by cement mortar as follows:

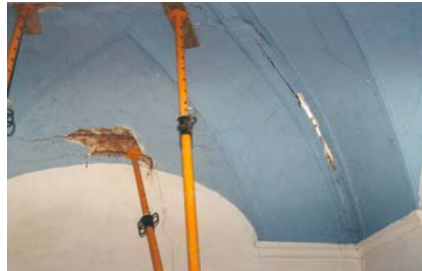
Figure 7- Detail in interior of the vestry vault

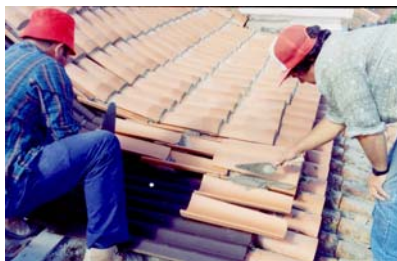
Figure 8—Ceramic tiles placed over a synthetic under-roof

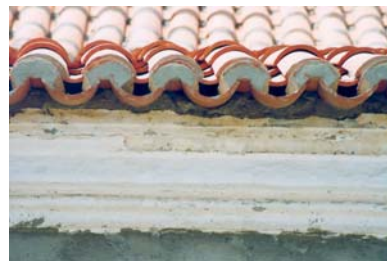
Figure 9- Detail of the roof edge finishing

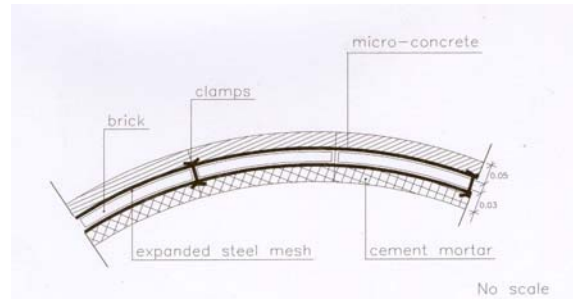
Figure 10- Schematic picture of the intervention at the vestry vault

Exterior – micro-concrete

(1 cement: 1 river sand: 2 gravel), about 5 cm thick. To reduce load on the structure, we used a light inert material – expanded clay – mortar with a cement grout

Interior – cement mortar (1 part cement: 4 parts river sand), about 3 cm thick.

The original vault remained between the micro-concrete and cement mortar like a sandwich. The mesh was spread 0.30 m down the inside lateral walls to guarantee connection between the walls and the vault. These techniques had previously been successfully applied to restore the vaults at the S. Francisco Convent in the city of Beja (Appleton,1994).

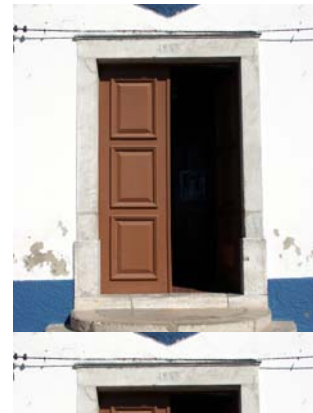
However, the use of cement in the exterior renders caused some compatibility problems after several years, namely the loss of limewash (Figure 11).

Figure 11- Main door of the church

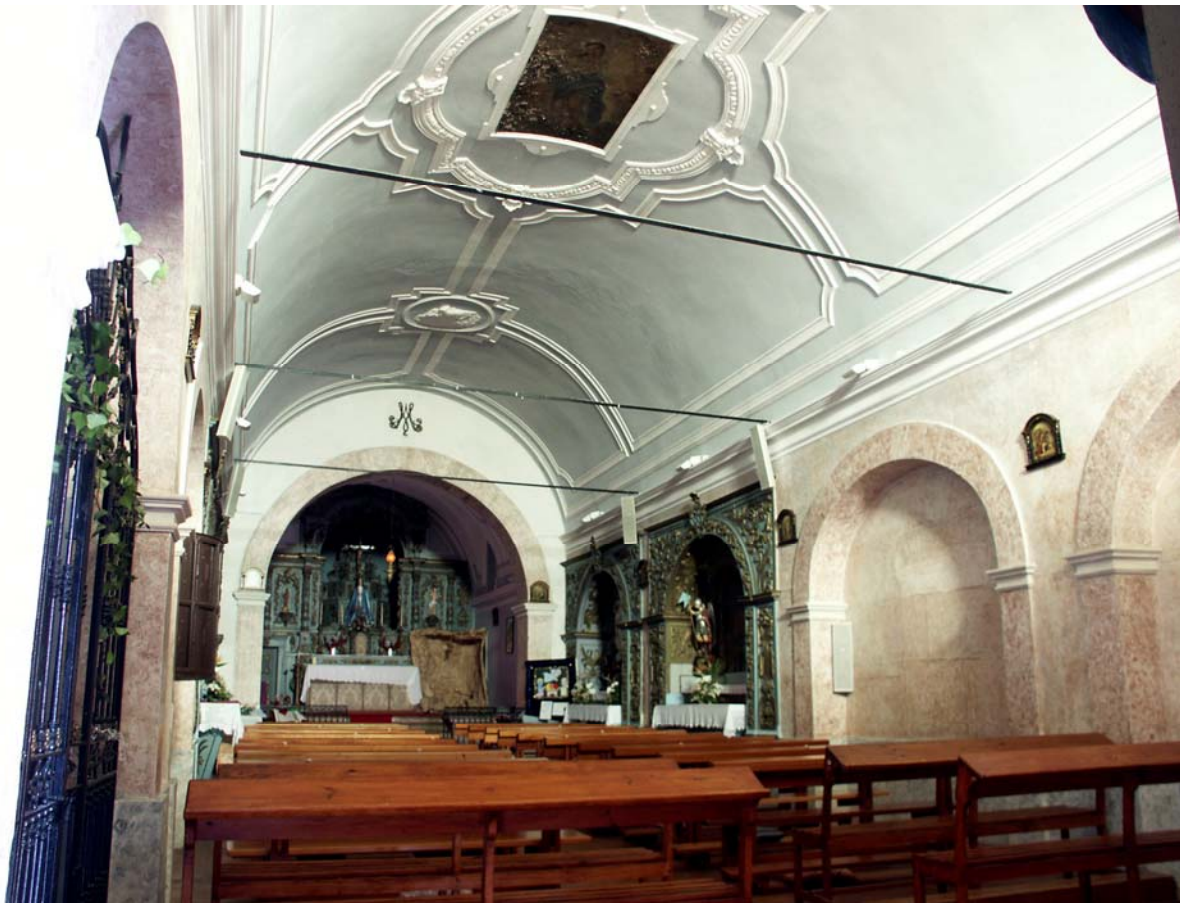
Figure 17- Actual appearance of the church interior

In the interior of the church, the secco-painting area was covered with a micro-crystalline wax to achieve a light sheen quality after slight polishing, which imitated the marble stone (Figure 17).

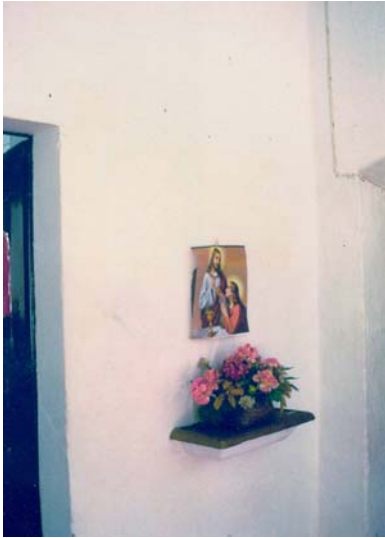
Figure 18- Interior aspect of the sacristy before the restoration

In the vestry vault, gypsum components such as flower work, were restored. After removing several layers of lime from the walls, paintings were found. We decided to keep that decoration in the door frame and in the hand-washing basin because we didn't want to interfere with the global appearance of the church (Figures 18 and 19).

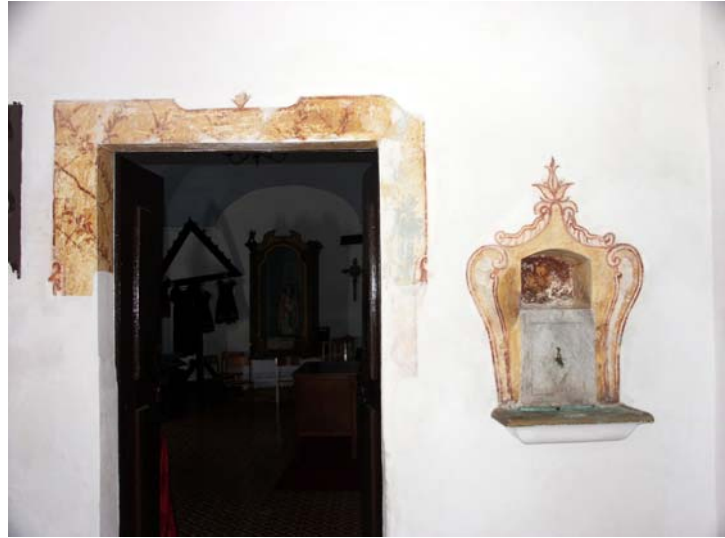
Figure 19- Appearance of the sacristy after restoring wall paintings
