THE USE AND EFFECTIVENESS OF DISPERSED HYDRATED LIME IN CONSERVATION OF MONUMENTS AND HISTORIC STRUCTURES*

P. Miller¹, M. Rabinowitz², & J. Sembrat³

3 DHL injection grout case study: Barnard Statuary

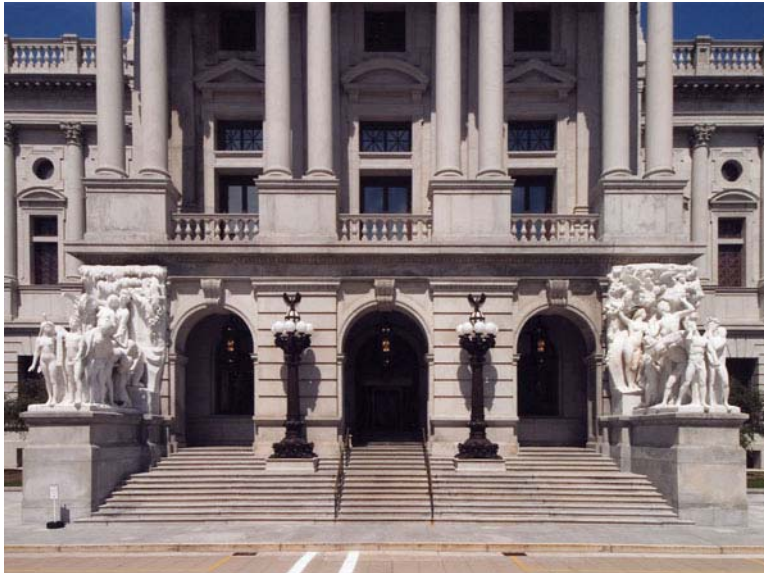
Figure 1: Barnard Statuary Group, Pennsylvania State Capitol Building, Harrisburg, Pennsylvania.

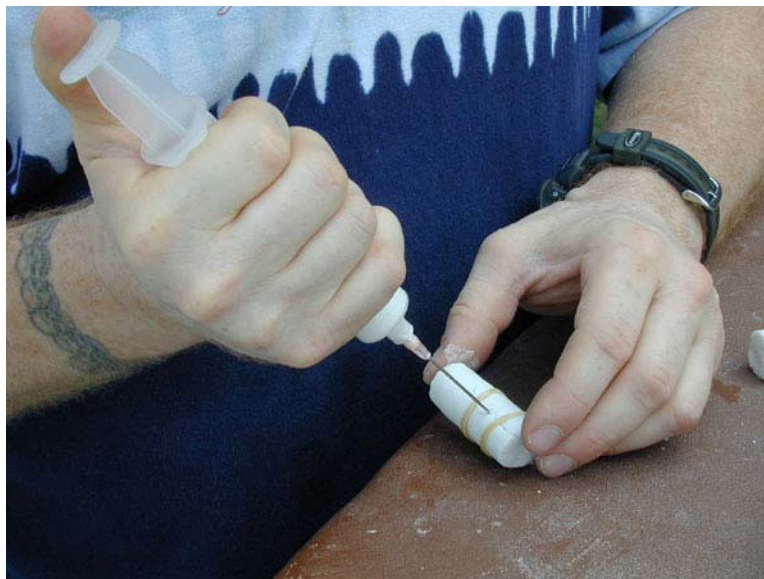
Figure 2: Preparation of DHL injected split marble cores for accelerated weathering testing (2001).

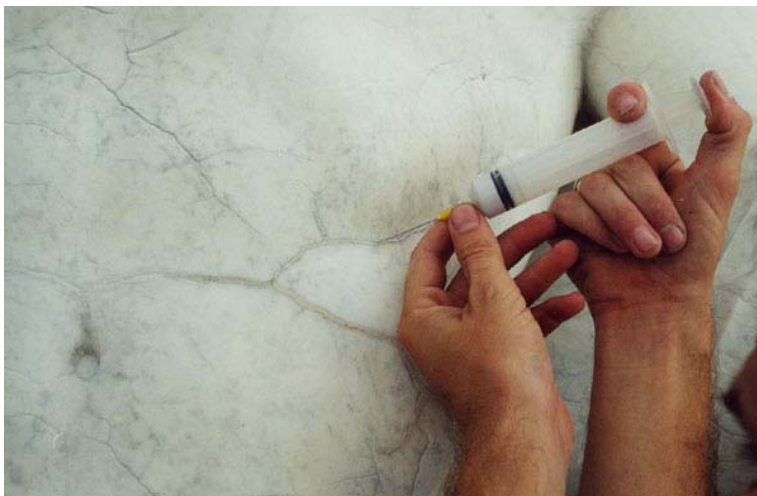
Subsequent to the 2001 testing, the authors began a 5-year cyclical maintenance program to monitor the condition of the sculpture group, including all repairs. DHL crack repair was initiated during the summer of 2001. In this first year, vertical and horizontal cracks were filled similarly; the DHL was filled flush with the marble surface and no misting of the fills was performed. (Misting of the fills was not performed as part of the testing program and, therefore, was not performed in the first year of field application.) Field application results proved less successful than anticipated following the 2001 accelerated weathering test results. While DHL fills on vertical and partly protected faces were

remarkably stable, those installed on upper exposed areas were subject to erosion and loss from driving rain and runoff.

Figure 3: DHL injections beginning in 2001 were intended for filling fine cracks less than 1mm in width. Epoxy injected cracks from the 1996 repair campaign, now yellow in color, are also visible.

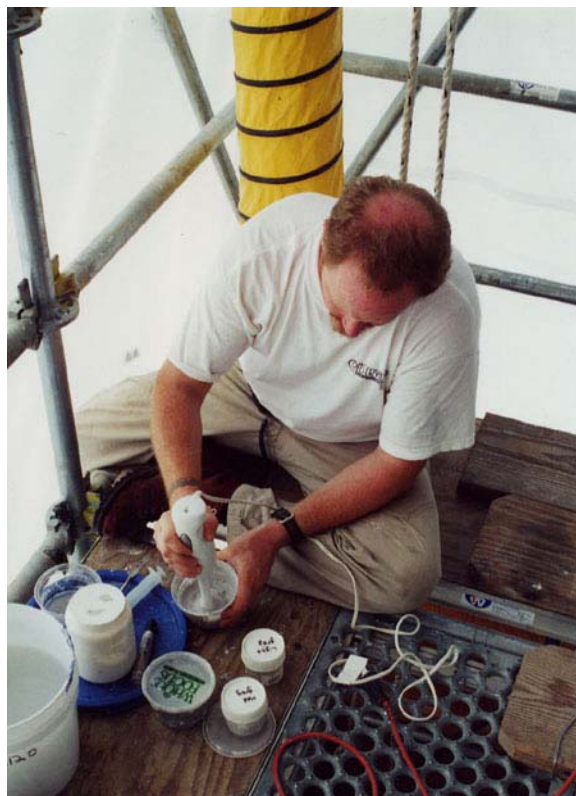
Figure 4: On-site mixing of DHL for injection.

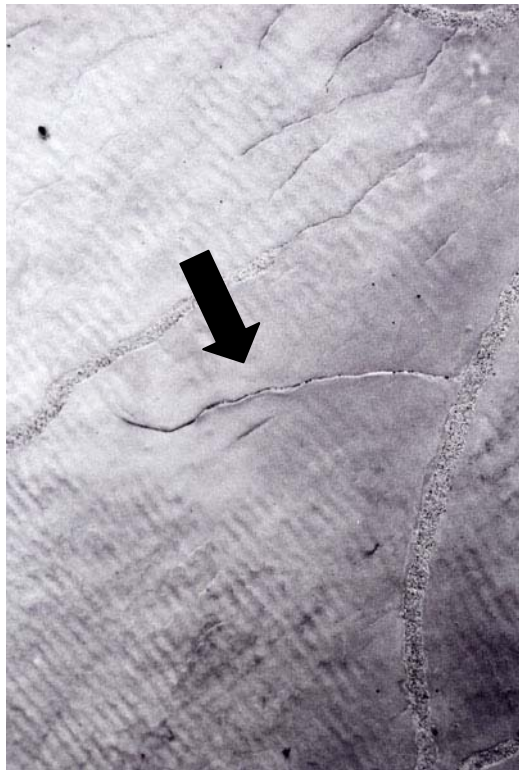
In 2003, the previous year's fills on exposed horizontal surfaces showed deterioration again, suggesting that the durability of DHL is not sufficient in these locations and in this environment. A decision was made to protect DHL-filled cracks by a more durable shelter coat or capping material. To address the durability issue, field tests initiated in 2003 used a number of modified DHL and lime-based mixtures in both injections and as capping material to protect the fills in these skyward-facing locations.

Figure 5: Inspection of DHL filled cracks in 2003 identified failures in exposed locations. DHL had eroded from cracks after a period of one year.

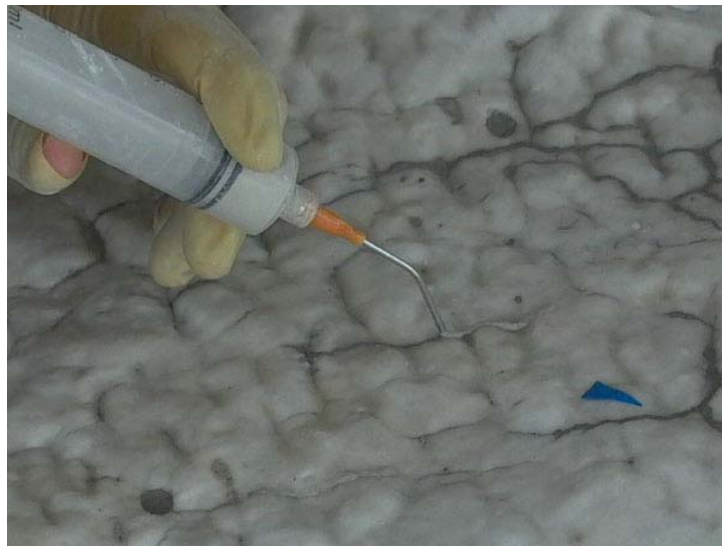
Figure 6: Injection of an NHL cap over a DHL filled crack in 2004. DHL is still wet and appears darker in the crack than the NHL.

In the summer of 2004, a new procedure, using DHL in the cracks and capping with a modified NHL-lime putty-marble powder mortar, was used on those surfaces that had proved most susceptible to failure. NHL 5 was mixed dry with fine marble powder, lime putty, and casein. Casein was added to help increase flow behavior of the material, as well as add some adhesion properties. Water was added until the mix reached a consistency capable of flowing easily through a syringe. Mixing ratios are provided in Table 4. The NHL mixtures were injected onto the surfaces of the cracks. These caps were not screeded, but were allowed to remain proud. Ideally, the consistency of the mix was such that the caps spread out slightly, thereby creating a gentle slope as opposed to a stiff peak and avoiding the creation of “undercuts” at the edges of the caps that could catch water and cause the caps to be undermined and fail (a problem observed in capping from the previous year’s field tests). All caps were misted intermittently for 2 to 3 days after application.

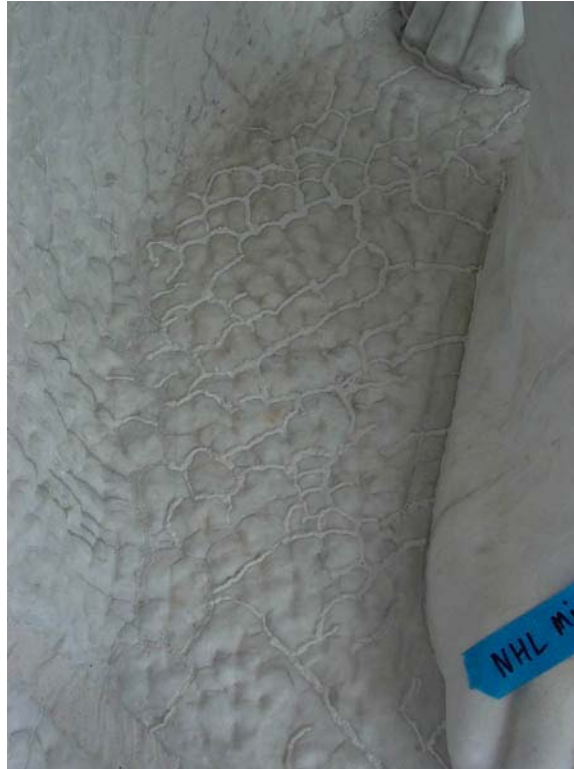
Figure 7: This area of the sculpture base is subjected to water runoff. Here all DHL fills were capped with NHL. This area is not visible from the normal viewpoint of the sculpture and therefore the caps were left proud.
