## **THEORETICAL CONSIDERATIONS ON CONSERVATION INTERVENTIONS\***

**A. Elena Charola<sup>1</sup> and Fernando M.A. Henriques<sup>2</sup>**

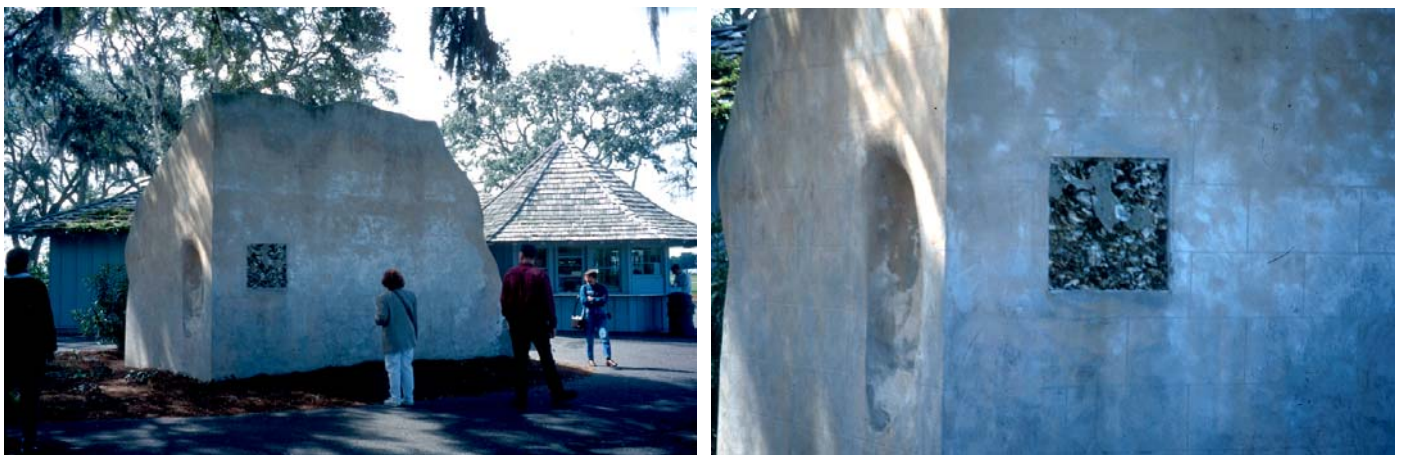
*Figure 1 View of the “conserved” remnants of the Retreat Plantation ruins, now within a golf club, on St. Simons island, GA. At right, a detail of the square left without render to show the internal structure of tabby.*

While the conservation of archaeological heritage requires a different approach than that of architectural heritage, construction that is to be left exposed to the open requires interventions, such as maintaining the renders. Because ruins do not have a roof to protect them, one such intervention may be the application of a capping, changing the appearance significantly. The change in appearance could be mitigated if the “identifying” value is considered important enough to use shells as the finish of the capping. Since the capping itself is clearly not part of the original structure, this shell finish could serve to mitigate the rounded shape generally given to cappings which, in this instance, is at odds with the sharp edges of traditional tabby construction. Figure 1 illustrates a conservation intervention on some of the Retreat Plantation ruins on St. Simons Island, Georgia.

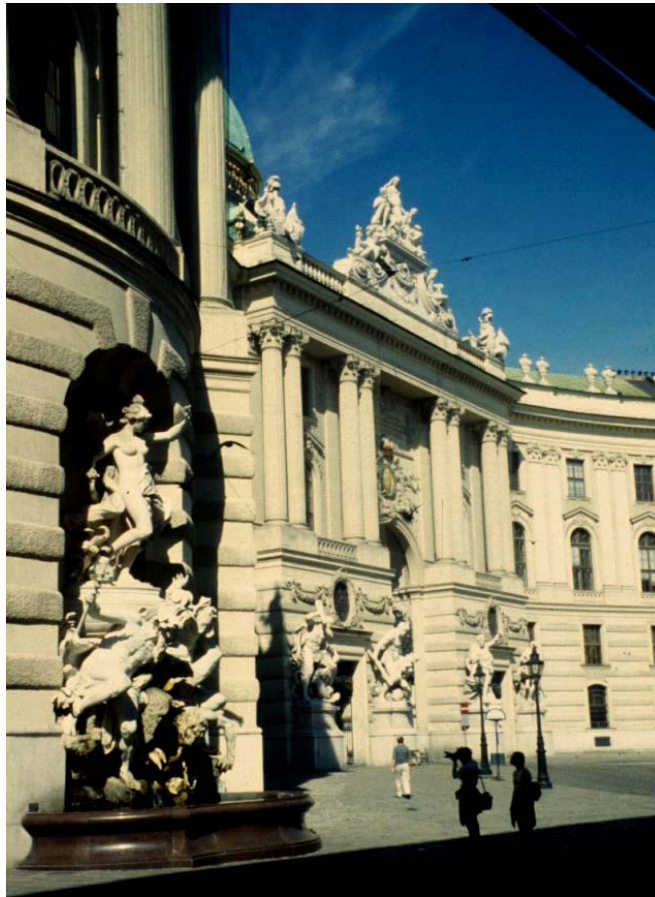
*Figure 2 View of the entrance to the Hofburg in Vienna (Austria). The sculpture group that decorates one of the two fountains is carved of Laaser marble (seen at left), while the other sculpture groups are carved in a soft limestone and have received a lime-based sacrificial coating.*

Based on this approach, a sacrificial coating (“*Opferschlämmen*”) was developed using lime putty (no powdered hydrated lime should be used) that was carefully sieved to obtain a uniform, adequately small, particle size. A thick suspension was prepared and applied by brushing on a damp surface. Subsequent coats were applied wet-on-wet. This coating diminished the roughness of the weathered stone and provided a white finish that is similar to marble. Although this approach has received criticism within Austria, it attains the objective: sculptures having received this treatment are undistinguishable from those carved out of the Laaser marble used in Austria, unless examined close at hand and by a specialist (Figure 2).

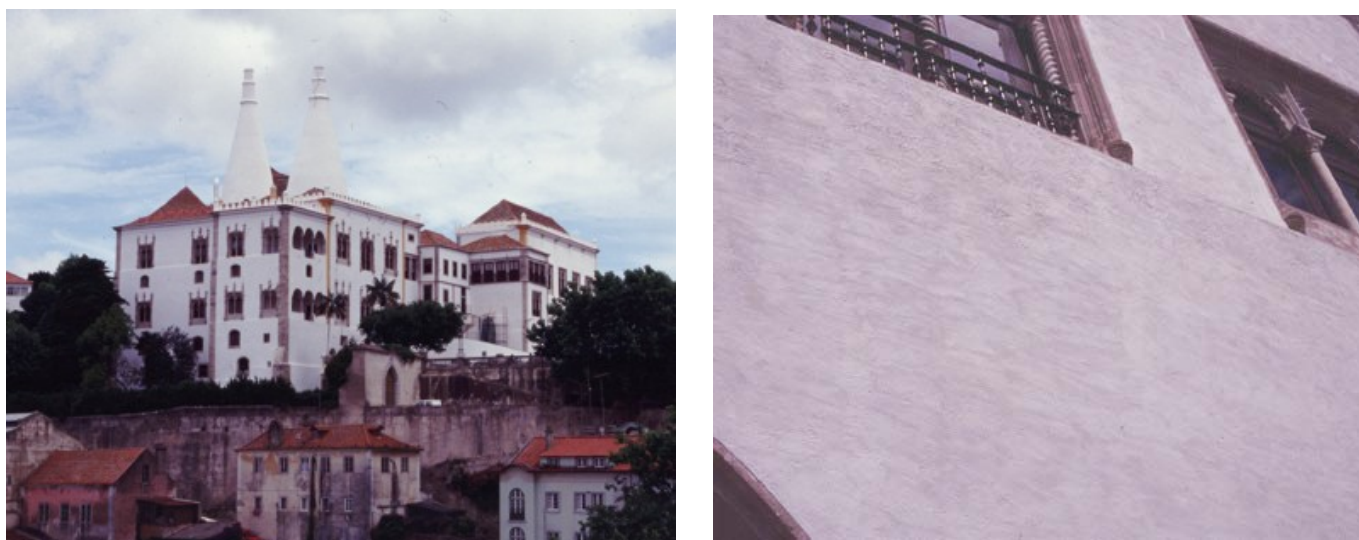
*Figure 3 The large conical chimneys at the National Palace of Sintra are its landmark feature (left).  
Detail of the final appearance of the cleaned and patched render (right).  
The traditional lime formulation showed excellent compatibility with the original render.*

The revised approach was based on the philosophical principles referred to previously, and took into account the fact that the existing renders were really in very good condition. Actually, there were several layers of superimposed mortars applied throughout the centuries. Thus, simple removal of the biological colonisation by brushing and application of a fungicide were the only steps needed to achieve the main objective: conservation of the existing materials and removal of the poor visual aspect of the building. In areas where the render required some patching, the application of a pure lime-sand (1.5: 4) mortar was used. This traditional formulation achieved an excellent performance in terms of adhesion, strength, dimensional stability and with no significant cracking. The application was completed with a surface finish of a thin “*marmorino*” layer, based on a lime putty and marble powder mortar (1:2) to which a final limewash coat was applied to correct any minor cracking that might occur (Figure 3). This two-step finish served to give the final white color to the surface. In
