HYDRATED LIME AS AN INGREDIENT IN HISTORIC RESTORATION REPAIR MATERIALS*

Abstract

1 Introduction

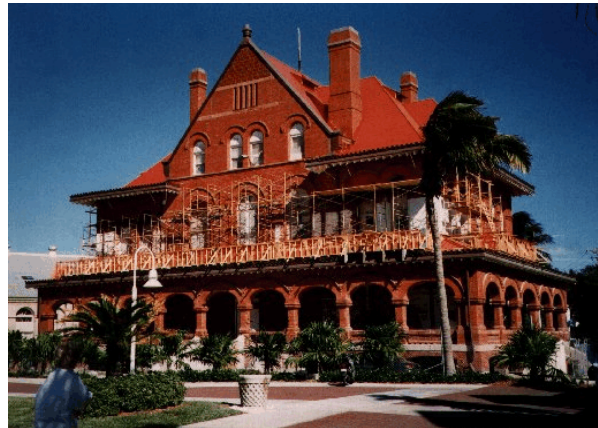
Figure 1. Custom lime-cement repointing mortars for the Key West Customs House simulated, but did not replicate the original mortar, in which poor practices were evident.

When mortar analyses were performed on a series of 90-year-old historic mortars during restoration of the Key West, Florida U. S. Customs House (shown in Figure 1), two major deficiencies were discovered. First, red iron oxide pigments had been used at a level of more than 20% by weight of the portland cement content. Modern standard ASTM C 979, Standard Specification for Pigments for Integrally Colored Concrete, limits the use of iron oxide pigments

At the U. S. Customs House, a decision was made to produce a mortar meeting the property requirements of ASTM C 270, Type N, properly limit the pigments to 10% by weight of the cementitious binder, and utilize a blend of sands meeting the requirements of ASTM C 144. Sand fineness was controlled to produce the finest particle size distribution allowable under the ASTM C 144 standard, in order to approach the composition of the original mortar as closely as possible while complying with the modern standard.

The restoration mortars finally produced for this project satisfied both the historic repointing and performance guidelines, while visually matching the original, historic mortars. Although approaching the original material in composition as closely as possible, the repair mortars were formulated for function first, as a well-engineered simulation was deemed preferable to replication of a mistake.

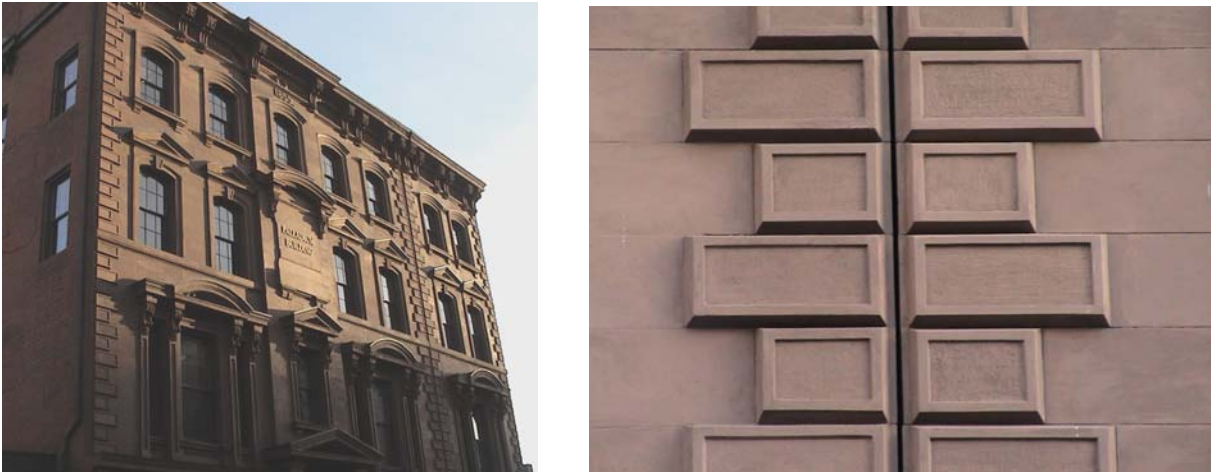
Figure 2. The 1855 Landmark Palladium Building, New Haven, Connecticut (left) shown in 2004, 22 years after application of some 16,000 lbs. of custom latex-modified lime-cement repair mortar. Cast-in-place quoins (right) retain sharp detail, exhibit no evident deterioration and are not readily distinguishable from the original stone.

For the repairs at the Palladium Building in New Haven, Connecticut, seen in Figure 2, the performance properties given the highest priority were high tensile bond strength, low-modulus of elasticity, and low drying shrinkage. High adhesive bond strength was considered the primary performance property, as it is a prerequisite to all of the other properties. Low-modulus of elasticity was considered critical to durability, as the face-bedded Portland, Connecticut brownstone substrate was in poor condition, low in cohesion, and likely to be distressed if more rigid repair mortars were applied. Low shrinkage was deemed important in order to eliminate stress to the substrate during cure and to provide of crack-free surfaces for maximum protection of the water-sensitive sandstone.

Some 16,000 lbs (7270 kg) of repair mortar were placed in 1982. Twenty-one years later, when the building was pressure-washed following its sale in 2003, virtually all of the 1982 mortar was found to have remained in excellent condition (Figure 2). At ground level, minor repairs were required in a limited area that had been affected by winter snowplowing operations, and several small areas of previously unrepaired and subsequently exfoliated brownstone surfaces were also addressed.

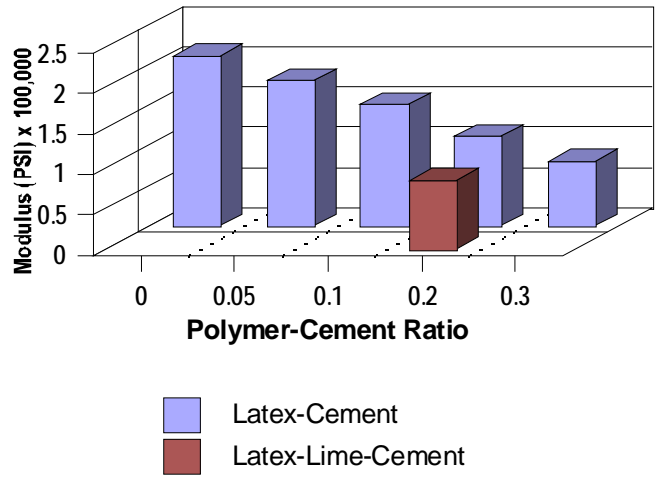
Modulus vs. Polymer-Cement Ratio

Figure 3. Effect of Polymer Concentration and Lime Addition on Modulus of Elasticity (Lavelle, p. 14)

For both modifiers, the level of modifier use was on the order of 3% on a dry basis. This equaled a polymer-cement ratio of 0.15 for the latex modifier. Both modifiers reduced the modulus of elasticity and provided superior stress-relief and distress-avoidance to the soft brownstone substrate. The effect of polymer and lime addition on modulus is shown in Figure 3.

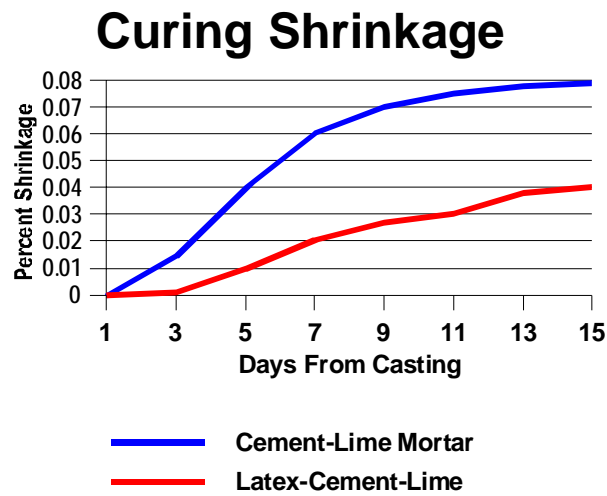
Figure 4. Curing Shrinkage of Latex-Modified and Unmodified Cement-Lime Mortars (Edison, 1998)

The tendency of lime to increase drying shrinkage was more than overcome by the tendency of the latex admixture to reduce shrinkage through significant reduction in water demand. Shrinkage of the mortar was sufficiently low that even relatively fluid mixtures, prepared for pouring in-place repairs up to 6 inches (15 cm) in thickness and up to 2 feet or more in height and width (60 cm), did not cause development of any visible shrinkage cracks. ICRI Guideline #03733 defines “Low Shrinkage” as less than 0.05% and more than 0.01%, while defining “Moderate Shrinkage” as more than 0.05% and less than 0.10%. The addition of latex to the lime-cement mortar, in this case, reduced the shrinkage from “moderate” to “low”. Low-shrinkage materials are preferred due to their reduced tendency to crack. Cracks of width exceeding 0.008” (0.2 mm) will leak when exposed to intermittent moisture, and the transmission of this moisture to the repair interface can be expected to diminish patch durability. Comparative shrinkage data for a cement-lime mortar and a latex-modified cement-lime mortar are shown in Figure 4.

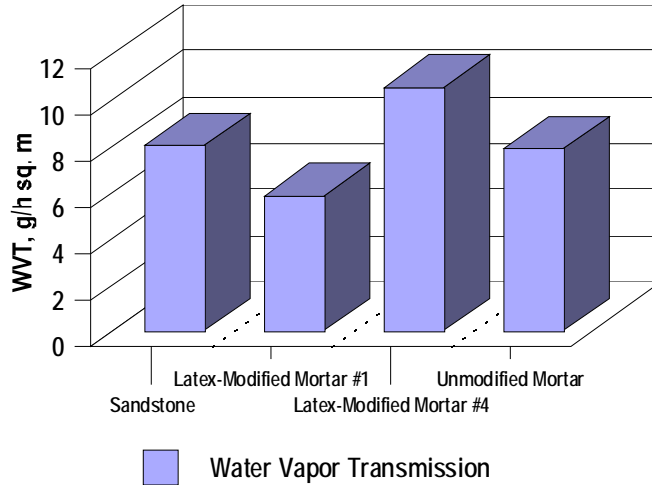
Water Vapor Transmission, ASTM E96

Figure 5. Water Vapor Transmission in Sandstone and Commercial Repair Mortars (Edison, 1997 & 2001)

Moisture vapor permeability was controlled through adjustment of sand proportions and particle size distribution. This approach allowed creation of sufficient air voids within the cured mortar to permit free transmission of moisture vapor. Comparative water vapor transmission data for a sandstone specimen, two commercial latex-modified cement-lime repair mortars, and one unmodified commercial repair mortar are listed in Figure 5. The study utilized specimens of 6 mm thickness that were tested using ASTM E 96 Standard Test Methods for Water Vapor Transmission of Materials (water method). All specimens displayed rates of water vapor transmission close to the rate of the sandstone specimen. Latex-modified mortar #4 displayed the highest rate of moisture vapor transmission. It differed from latex-modified mortar #1 only in its air void volume.

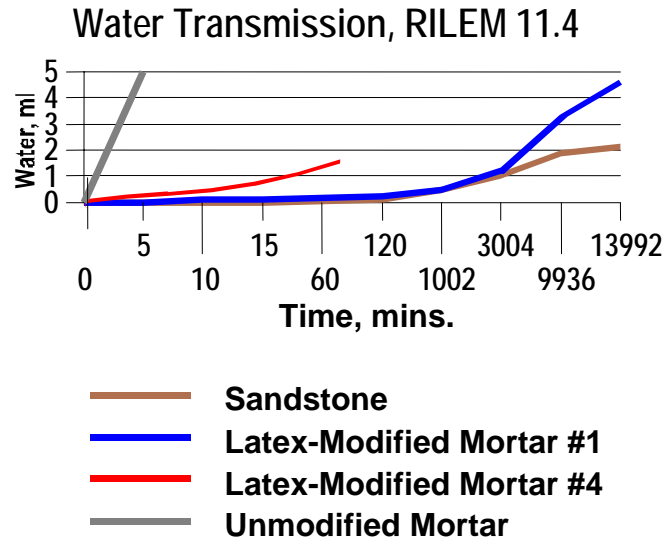
Figure 6. Liquid Water Transmission in Sandstone and Commercial Repair Mortars (Columbia University)

As seen in Figure 6, the results of this testing indicated that the rate of liquid water transmission of the latex-modified Mortar #1 was closest to the sandstone’s rate. Latex-modified Mortar #4’s water transmission was an order of magnitude higher than the sandstone. Transmission through the unmodified mortar was three orders of magnitude faster, with water leaking all the way through the specimen within 5 minutes. The moisture vapor and liquid water transmission test results were combined to lead to the conclusion that latex-modified Mortar #1 most closely resembled the original stone with regard to these characteristics. This was the formulation used in the restoration of the Palladium Building.

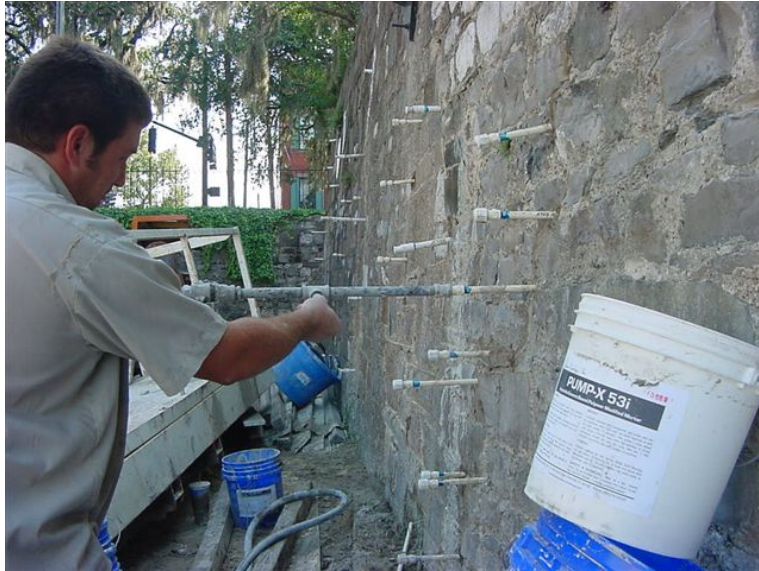
Figure 7. Injection of polymer-modified lime-cement grouts on historic masonry retaining walls on Factors Walk in Savannah, GA, was performed using two different grout formulations.

The same dual grout approach was used to stabilize historic masonry retaining walls in the City of Savannah, Georgia. Large cracks, caused by horizontal displacements, were injected with the coarser grout, while finer cracks were injected with the finer grout. In both applications, a positive displacement grout pump was used to deliver the grout to sections of small diameter steel pipe set into the wall at injection points prepared along the length of the cracks. Refer to Figure 7. Pipe nipples were set in a lime-cement masonry mortar, matched to the existing historic mortar. Grout was pumped into each port until it emerged from the adjacent port. According to field observations, no difficulties were encountered in achieving grout flow to adjacent ports and, in some cases, grout emerged from ports up to 6 feet (2 m) from the injection point. Based on these observations, the grouts were determined to have effectively achieved the objectives of the project: filling a wide range of cracks and voids, achieving efficient flow, and providing positive aesthetics, as shown in Figure 8.

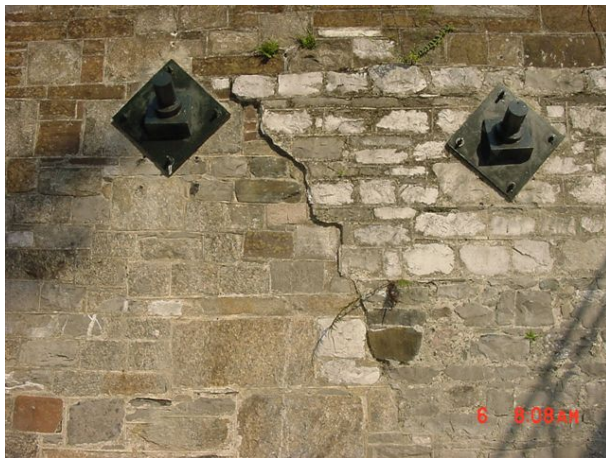
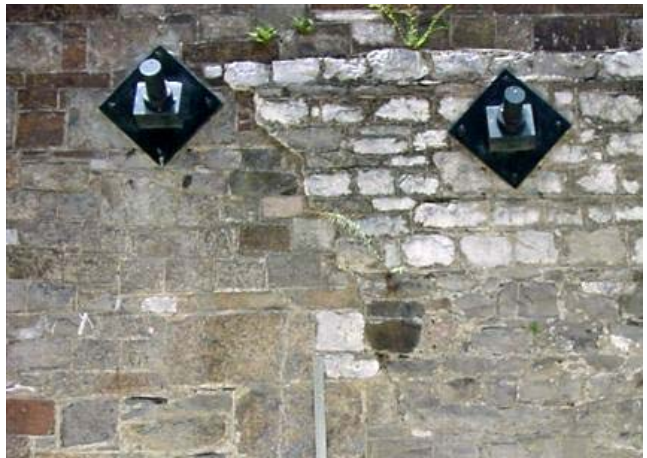
Figure 8. Cracks in Historic masonry retaining walls on Factors Walk, Savannah, GA, before and after injection with a combination of fine and coarser polymer-modified grouts.

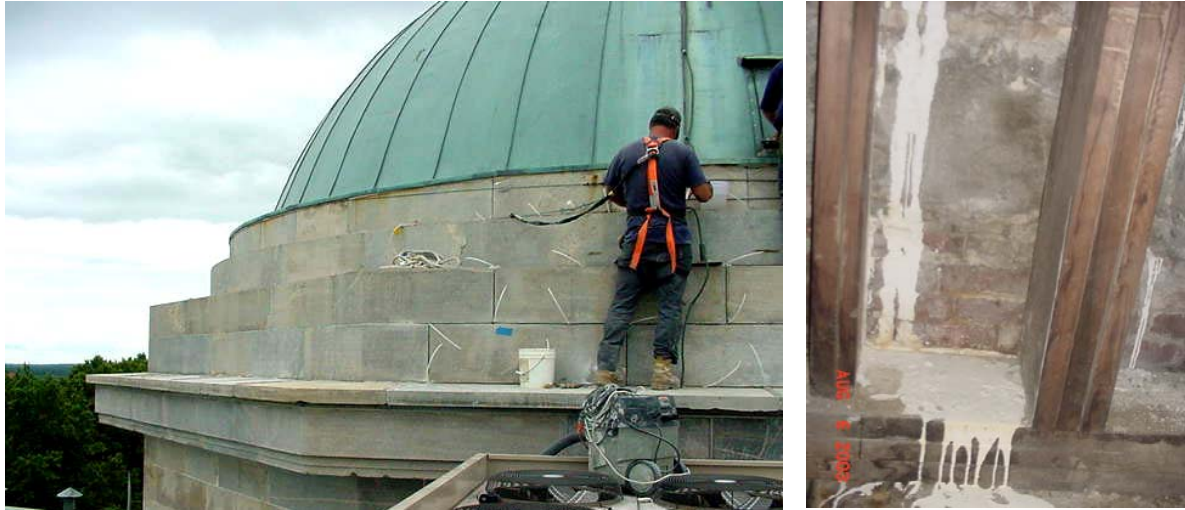
Figure 9. Workers prepare injection tubing for installation of lime-based grout at the North Carolina State Capitol (left). In some areas (right) the lime grout flowed all the way through the masonry to the interior surface .

Work on the octagonal dome, shown in Figure 9, was undertaken to restore watertight integrity, which had been compromised by cracked masonry mortar joints between the dome's stone blocks. Old mortar joints were raked out to a depth of 1" and ¼" diameter holes were then drilled to a depth of 6" to 8", spaced at 2' on center along the length of each of the raked and cleaned joints.

Sections of plastic tubing, ¼" in outer diameter and 18" in length, were inserted into each hole and stabilized with custom matched prepackaged lime mortar. All joints were then repointed with custom lime mortar to within ¼" of the original joint surface. Water was injected into each tube in preparation for grouting. Bulk caulking guns, reduced to a ¼" tip size, were used to inject the lime grout into the plastic tubes. Each port was injected until one of the following occurred:

1. Grout emerged from the adjacent port
2. No further grout flow could be achieved
3. Grout emerged on the interior surface (Figure 9, Right)
4. Four to five quarts of grout were injected into any single port
