THE STRANGE HISTORY OF THE ENGLISH LIME REVIVAL *

Bruce Induni¹

Abstract

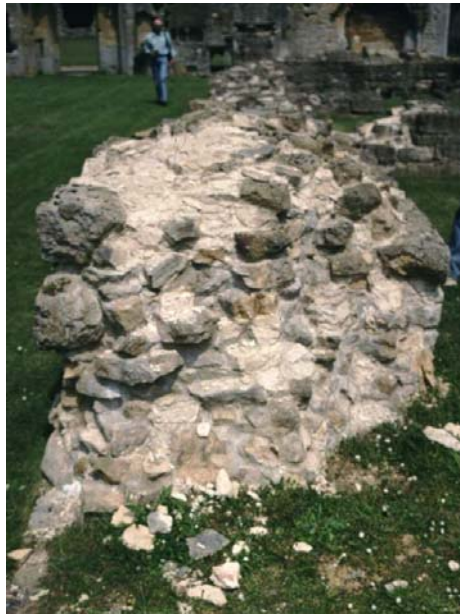
Figure 1. An example of the capping of a ruin wall.

Baines' most pressing problem was to contrive a way of water-proofing the tops of ruined walls. (Kirkstall Abbey report, 1926, Appendix 2, pp.1-9) (Thompson M. W., 1981, p.24). He did this by taking down the uppermost courses of original masonry and rebuilding them using 'modern' mortar and by realigning the core stones to shed water. The process later became known as 'rough racking', and was usually combined with deep pointing or grouting. It was an elegant solution in some ways. To the untrained eye, 'rough racking' creates the illusion that the wall has not been altered by the conservation process. Some, but not all, find this 'conservation by invisible hand' approach attractive. Others think it is fundamentally dishonest to present new work as old. Baines appears to have been unassailed by doubt, though a vocal minority protested loudly and publicly (Peto H. A., 1921, p.593).

On the scaffold, 'rough racking' and deep pointing posed more than ethical problems. Baines tackled these in detail in the 'Instructions to Foremen':

(d) Where the raking out exceeds 3 inches in depth the joints are, before pointing, to be tamped with cement mortar well hammered home with special tools [sketch of 'tamping iron']. The cement mortar is to kept back a minimum of 2 inches from the face of the wall." (Baines F., 1914, p.109)
