## **REVIVING NEW ORLEANS' OLDEST CEMETERY: PRESERVATION OF ST. LOUIS CEMETERY NO. 1 THROUGH THE RE-INTRODUCTION OF TRADITIONAL MATERIALS\***

### **Abstract**

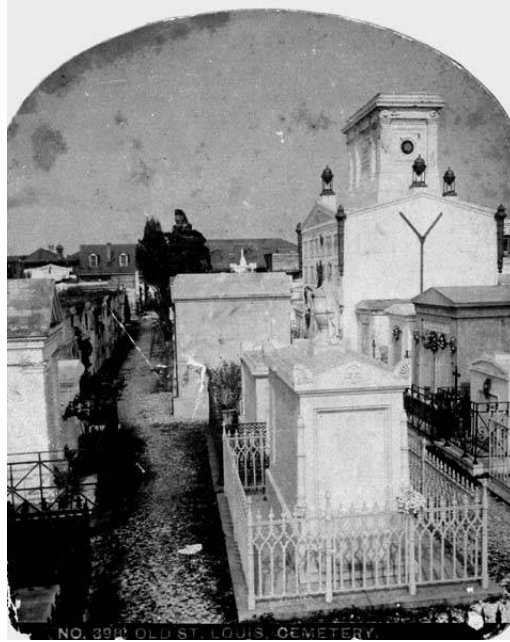
*Figure 1. A circa 1875 view of Alley 9L in the St. Louis Cemetery No. 1, taken by photographer G.F. Mugnier (photograph courtesy of the New Orleans Public Library, Louisiana Collection).*

In November 2001, the non-profit organization Save Our Cemeteries obtained a grant from the federal Save America's Treasures (SAT) program to develop and implement a preservation strategy for the St. Louis Cemetery No. 1. The grant was matched by significant contributions from the Archdiocese of New Orleans, the University of Pennsylvania's Graduate School of Design, and the Booth-Bricker Fund. Using a pilot tomb preservation project completed in 2000 as a guide, as well as Peters' research, a technical preservation plan was developed for the cemetery. A key component of the preservation plan was the restoration of a typical row of tombs, a "tombscape", to its late nineteenth century appearance using traditional building materials and techniques. The restoration of a tombscape provides the visitor to the cemetery with a more accurate vision of its historical appearance. Alley 9L, at the rear of the cemetery, was selected for restoration because of the diversity of tomb types and conditions of deterioration exhibited by its thirty-one structures. This alley was also photographed by G.F. Mugnier in the late nineteenth century as part of a commercial series of souvenir views of the city. These images provided graphic evidence for restoration. (*Figure 1*)

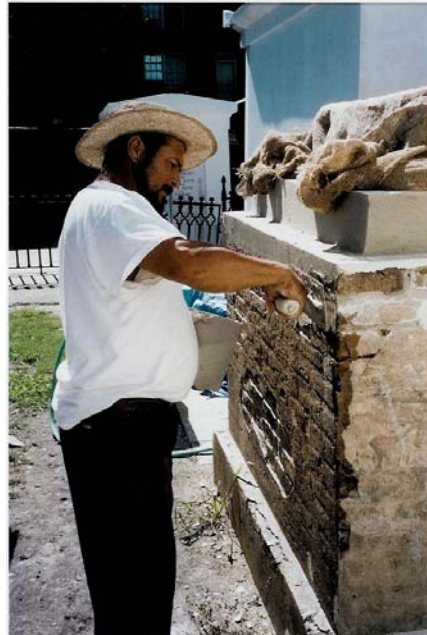
*Figure 2. A mason applies a hydraulic lime-based stucco on a step-style tomb. The new material is applied where the original is missing and care is taken to cover the new work with damp burlap (photograph by author).*

Once individual treatment plans were developed for each tomb, they were photographed and all molding profiles recorded by measured drawings. Following the documentation, the restoration work began. Restoration work typically involved cleaning, re-setting bricks, re-stuccoing and limewashing. Losses and cracks in flat stucco, where water and plant roots could easily invade, were filled with mortar and open brick joints were re-pointed. In addition, a local mason repaired the larger areas of stucco loss, such as on tomb rooftops and areas of ornamental stucco. For ornamental work, such as cornices and pilaster capitals, the mason was provided with a scaled drawing of the molding profile to be replicated, from which he created a sheet-metal template for the repair work. For small repairs, he carefully matched the existing molding through the use of hand-held masonry tools. (*Figure 2*)

For all stucco repairs and new stuccowork, a mixture of 1 part hydraulic lime to 2 parts sand (by volume) was used. This mix was based on the average results of Peters' acid digestion analysis of numerous stucco samples removed from the cemetery. In general, she found that the ratio of ingredients was typically between 1:1 to 1:2 (binder: aggregate) (Peters 2002, p 137). The bricks were re-pointed with a slightly softer mix, as Peters found that the mortar was the weakest component of the tomb construction (Peters 2002, p 177). The brick mortar was composed of a 1:3 (by volume) mixture of hydraulic lime and sand. Although Peters' research indicates that the original brick mortar does not contain hydraulic components, it was decided that such a mortar would be more durable than the original and would still be soft and permeable enough to be compatible with the historic materials. The only portion of the tombs where hydraulic lime-based mortars were not used was the roof. For the roofs, a 1:2:9 (by volume) mixture of white Portland cement, hydrated lime and mason's sand was used because it would produce a slightly harder and more weather-resistant protective skin on the tomb's most vulnerable surface. The roof, which receives a much stronger assault from weather than the sides, is typically the first area to deteriorate. Physical evidence has shown this to be true. Although historically, manufactured cement would not have been used in the stucco, it was used in this instance to better synchronize the rate of weathering of the tomb as a whole.

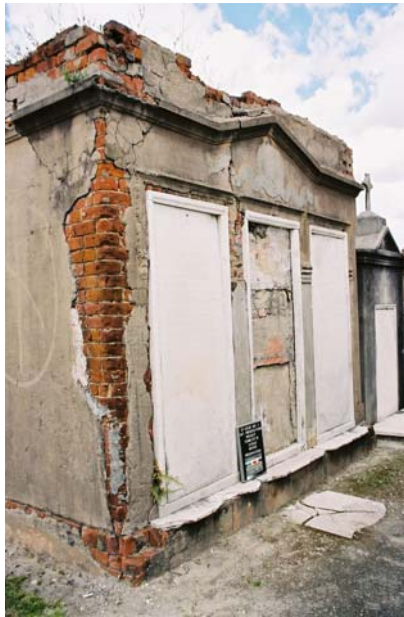
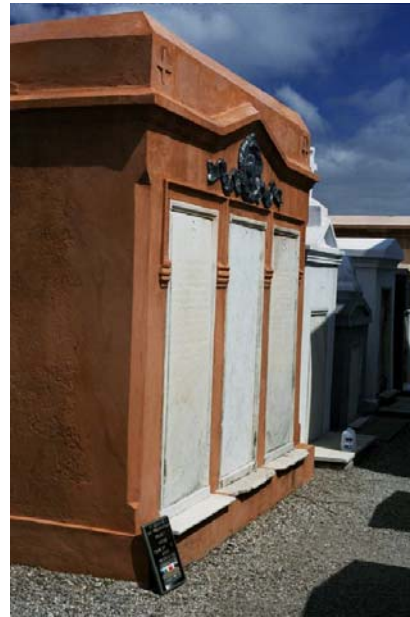
*Figures 3 and 4. The Malard Family tomb, before and after restoration. Work on this tomb included significant re-stuccoing, repair of marble closure tablets, recreation of missing metal decoration and application of its historic colored limewash (photographs by author).*

Examination of the samples revealed numerous layers of limewash and the sequence in which they were applied on each tomb. Unfortunately, it was impossible to identify which limewash color was on a tomb at a specific point in time. This ambiguity made selecting a consistent period of interpretation for all of the tombs on Alley 9L difficult. Therefore, each tomb was finished with one of its historic limewash colors, as documented in the laboratory analysis. This created a historically accurate appearance for the alley, although it was not strictly interpreted to one point in history. The limewashes were recreated using lime putty and iron oxides, much as it would have been done in the nineteenth and early twentieth centuries. In an effort to encourage the revival of this traditional finish, the materials had to be readily available to the Archdiocese and individual tomb owners. The lime putty was based on bagged hydrated high-calcium lime and the pigments were purchased from an art supply store. Workshops are frequently held locally instructing New Orleanians on how to apply this most traditional of tomb finishes. (*Figures 3 and 4*)
