LIME MORTARS: TWO RECENT CASE STUDIES*

Joshua Freedland¹ and Edward A. Gerns²

1.1 Case study 1

1.2 Case study 2

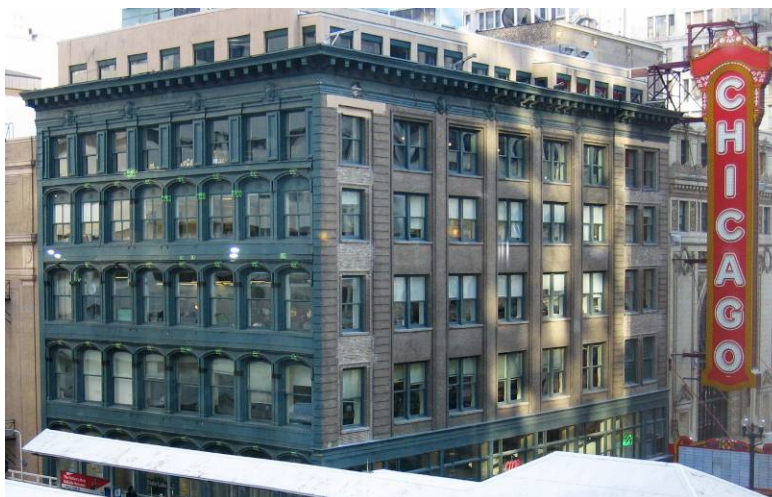
Figure 1 View of north and west facades of building.

The current phase of work resulted from a routine inspection of the building facade, when isolated masonry repairs were deemed necessary based on external observations and a limited number of inspection openings. In general, conditions observed during the evaluation indicated distress consistent with restraint of structural and thermal movements. Offset cracking within sill areas, missing mortar, and step cracking primarily through mortar joints were identified in the corner bays.

The first phase of the repair project included repointing of the brick masonry and other limited masonry repairs at the end bays of the building. Lime-sand mortar was selected to repoint the brickwork on the masonry facade for a variety of reasons. While chemical testing was beyond the scope of the project, the existing setting mortar installed throughout the facade appeared to be portland cement-lime-sand mortar, as would have been typical of the 1920s facade recladding project [Kidder-Parker, 241–246]. The composition of the backup mortar was not determined and, as mentioned previously, may date from the original 1870s construction. Lime-sand mortar is consistent with Chicago building practices in the 1870s and was likely used at that time [Speweik, 1995].

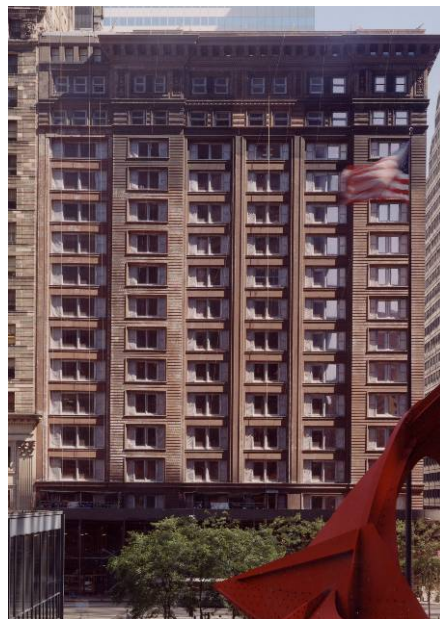
Figure 4 Overall view of south facade

Following an extensive inspection and investigation of the exterior facade, a multi-year facade restoration was implemented in 2002. The investigation included full documentation of the masonry and window conditions based on visual inspections, investigative probes, and partial disassembly of various components of the facade to evaluate and document concealed conditions. In addition, cleaning and material studies of the masonry were conducted.

The restoration included reconstruction of the cornice, facade cleaning, window restoration, and masonry repairs. Specifically, the masonry repairs included reconstruction of lintels, repair and replacement of deteriorated structural steel, repair of damaged and cracked terra cotta, and partial repointing of the brick and terra cotta masonry. The selection of mortar for repointing is discussed in detail below.

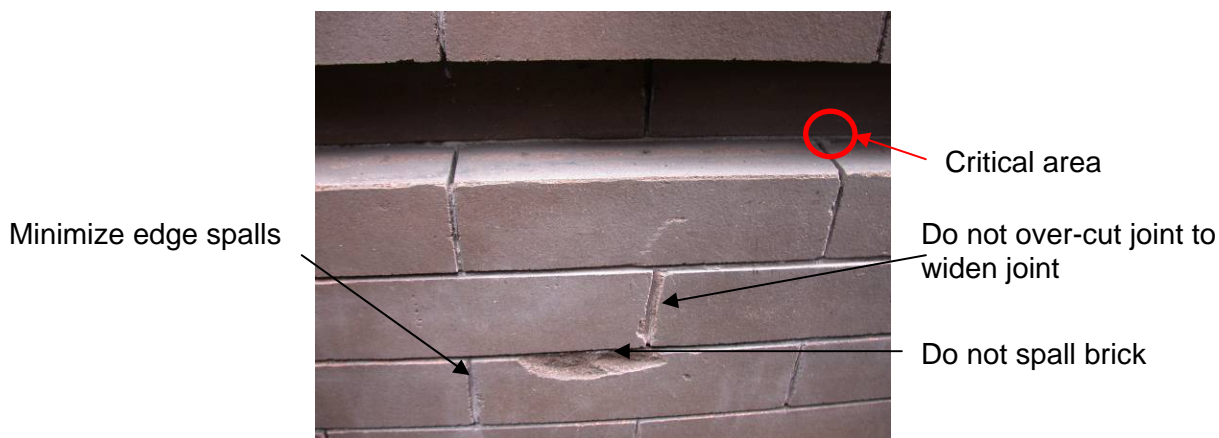
Given the softness of the brick and the narrow mortar joints, joint preparation presented a great risk of damage to the brick and terra cotta units. A joint preparation manual was created to assist the masons in deciding which joints to prepare and repoint, and which joints not to repoint if preparation would have likely led to damage of the masonry units. In general, the decision whether to repoint was based on the location of the joint, its proximity to embedded structural steel elements, the condition of the existing mortar, the width of the joint, and the ability to prepare the joints adequately without causing damage.

Figure 5 Sample of instructions from joint preparation guide

Since the bond between the mortar and the brick was intact at many locations, repointing of selected joints/areas was performed. The corner bays typically had a greater level of mortar distress, and joints in these areas were prepared and repointed to the greatest extent possible. The following rules were presented to the masons in a training booklet:

- No power tools were permitted to remove mortar from head joints.
- Special grinding blades, 0.04 inch thick, were used to prepare bed joints greater than 1/16 inch wide.
- Mortar joints at reveal courses were not prepared because preparation would have led to damage of the brick. The joints are protected from the elements by the geometry of the facade, and there was no embedded steel at this location.
